V. CULTURAL FEATURES OF THE MEMPHIS LANDING

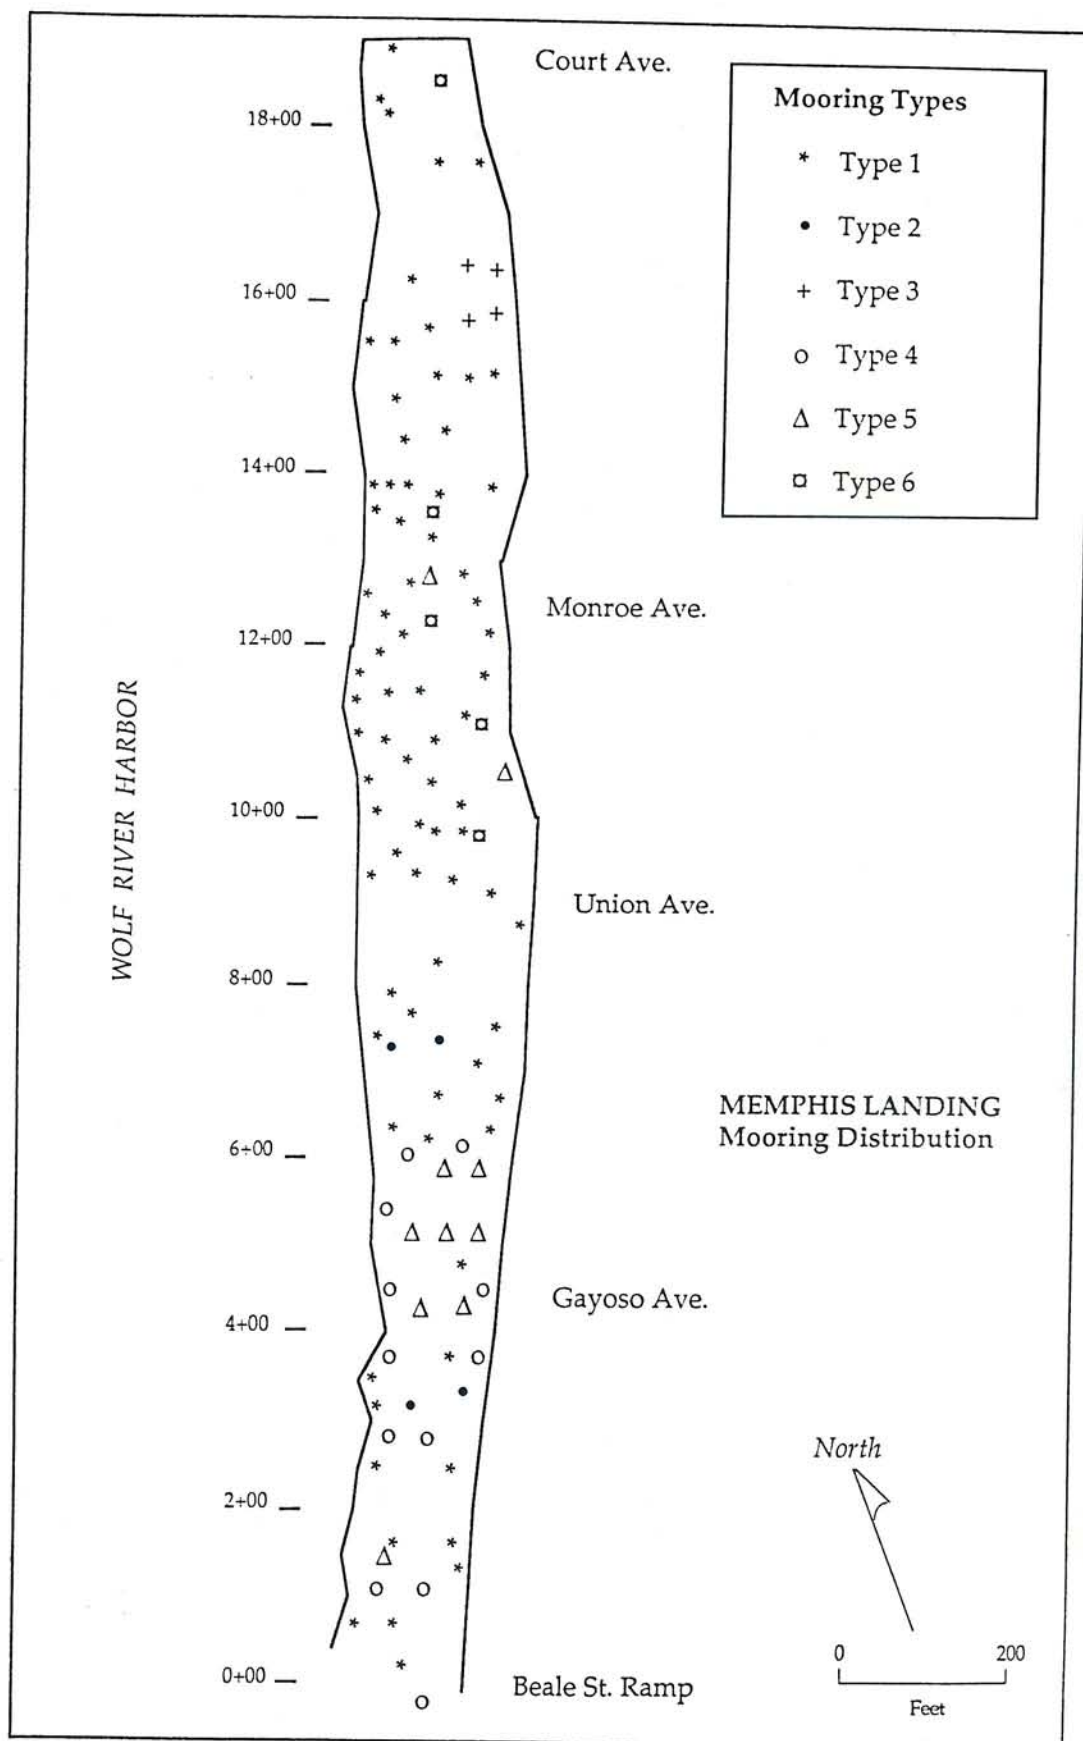
Figure 22. Mooring Distributions at the Memphis Landing.

A total of 112 moorings was recorded during the survey of the Landing (Figure 22). Also called "deadmen" and "ring bolts," the moorings are in various states of preservation. Many have been pulled completely out and are lost. Others are partially dislodged. Most are not functional. Some links have been stretched and broken, making them appear older than adjacent contemporary moorings.

The distribution of the moorings is shown on Figure 22. Of particular interest is the pattern of concentric arcs associated with the Type 1 moorings north of Union Avenue. As outlined above, the historical and lithological evidence suggests the Landing north of Union Avenue predates the South Memphis Landing. The association with Pattern 1 limestone suggests the Type 1 moorings are original to the stone fabric and were placed in a designed configuration. Type 1 moorings are present south of Union Avenue but are located in a random fashion. These may represent moorings salvaged from earlier construction.

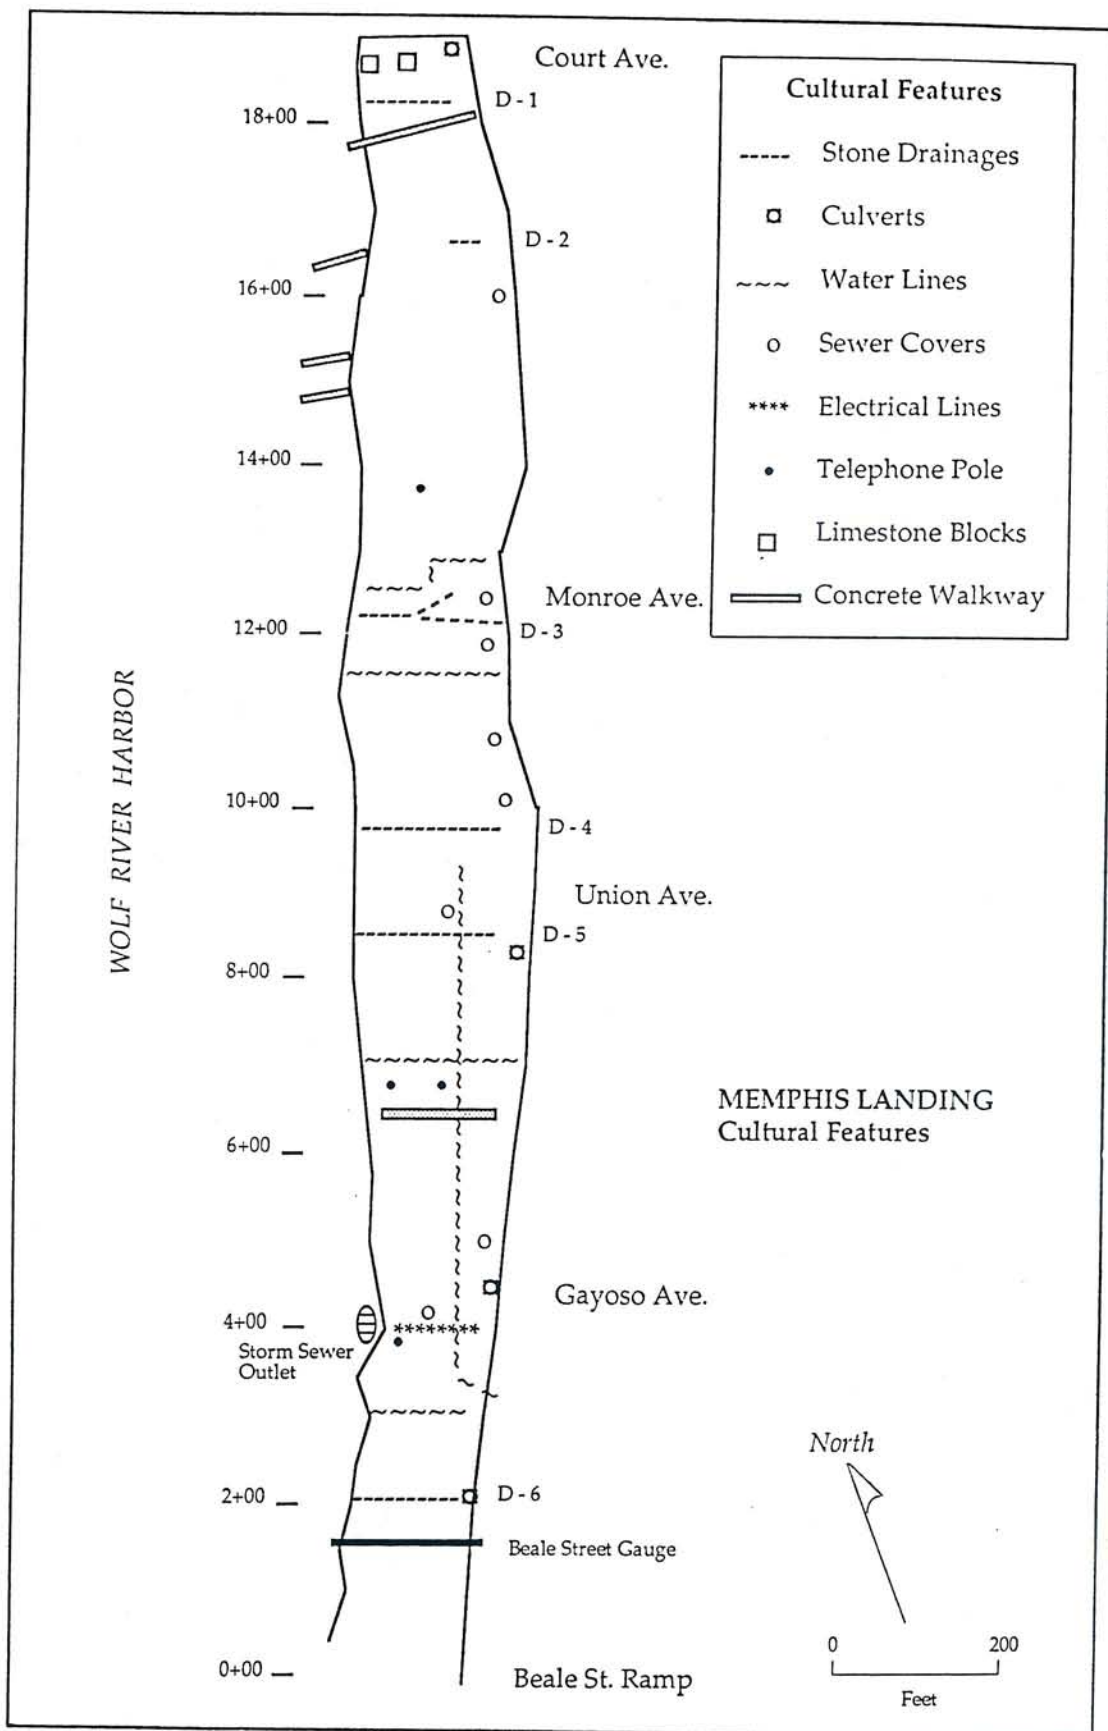
Figure 23. Miscellaneous Cultural Features at the Memphis Landing.

Four culverts are situated along the base of the Riverside Drive berm (see Figure 23). Beginning at the north end, the first is opposite Court Avenue at approximately North 1873. The second is south of Union Avenue (North 870) and almost matches the stone-paved Drainage 5. There are one culvert near the intersection of Riverside Drive and Gayoso Street (North 450) and one north of the Beale Street Ramp (North 220). The latter corresponds to Drainage 6.

Below-ground utility lines from the twentieth century include at least five water lines and one electrical line (see Figure 23). Water lines were recognized from the placement of water meters and spickets that tie into a water main that runs north-south beneath the Riverside Drive berm. Most the east-west water lines crossing the Landing are small. Except for a water line at North 330 covered with concrete, repaving has incorporated salvaged stones, and the lines are fairly inconspicuous. The exception is the large water line disturbance extending north-south across the pavement from about North 300 to Union Avenue (see Figures 23 and 33). The trench for this line was excavated in about 1992 to serve the Stacker Lee restaurant. The trench is approximately 3 feet wide and accommodates two PVC pipes. The stones were replaced haphazardly, resulting in alternating swales and ridges along the 600 foot length of the trench. The base of the trench is lined in concrete, which has disrupted the natural drainage by accumulating moisture and promoting vegetation (Figure 33).

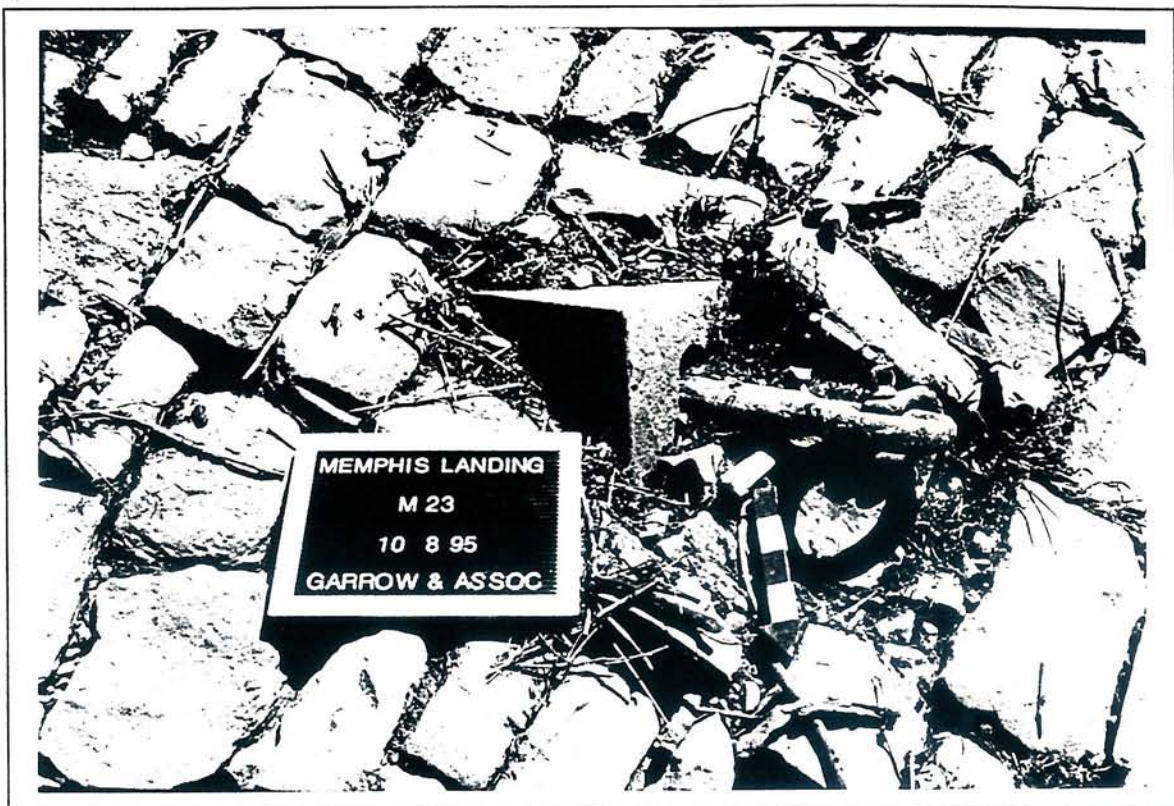
Figure 24. Mooring Type 1.

Type 1. This is the most common type of mooring (n=77, or 68.8 percent). It is present throughout the project area but most prevalent in the northern part. The type is recognized by a square iron plate at or immediately below the surface. The plate measures 1.0 x 1.0 foot and contains an oval opening through which the ringbolt stem extends from the top of the plate into an underlying cast iron or concrete block measuring 1.0 x 1.0 x 1.0 foot. The ringbolts are 2.5 inches thick and 7.5 inches in diameter. A variety of chain links can be attached to Type 1 moorings. A common configuration consists of a single large link (14.5 inches in diameter) connected to the ringbolt; two sets of smaller links (11 inches across) connect to the large link, which allows attachment by two separate tie-down lines.

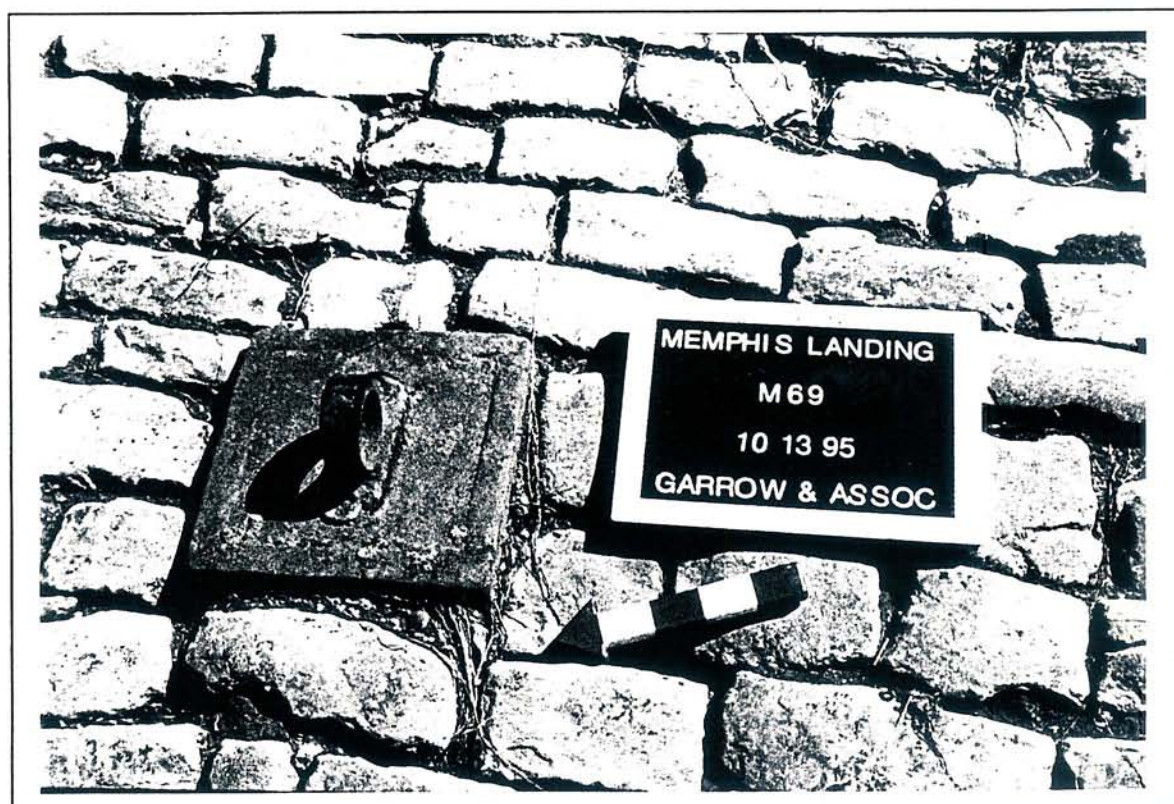
Figure 25. Mooring Type 2.

Type 2. Type 2 moorings (n=4, or 3.6 percent) are nearly identical to Type 1 moorings. The major difference is the face of the square iron plate. Type 2 moorings have an indented face bordered by a raised band along the edges. Two pairs of Type 2 moorings are in the southern part of the Landing. The first pair is between North 300 and North 350, the second at about North 550.

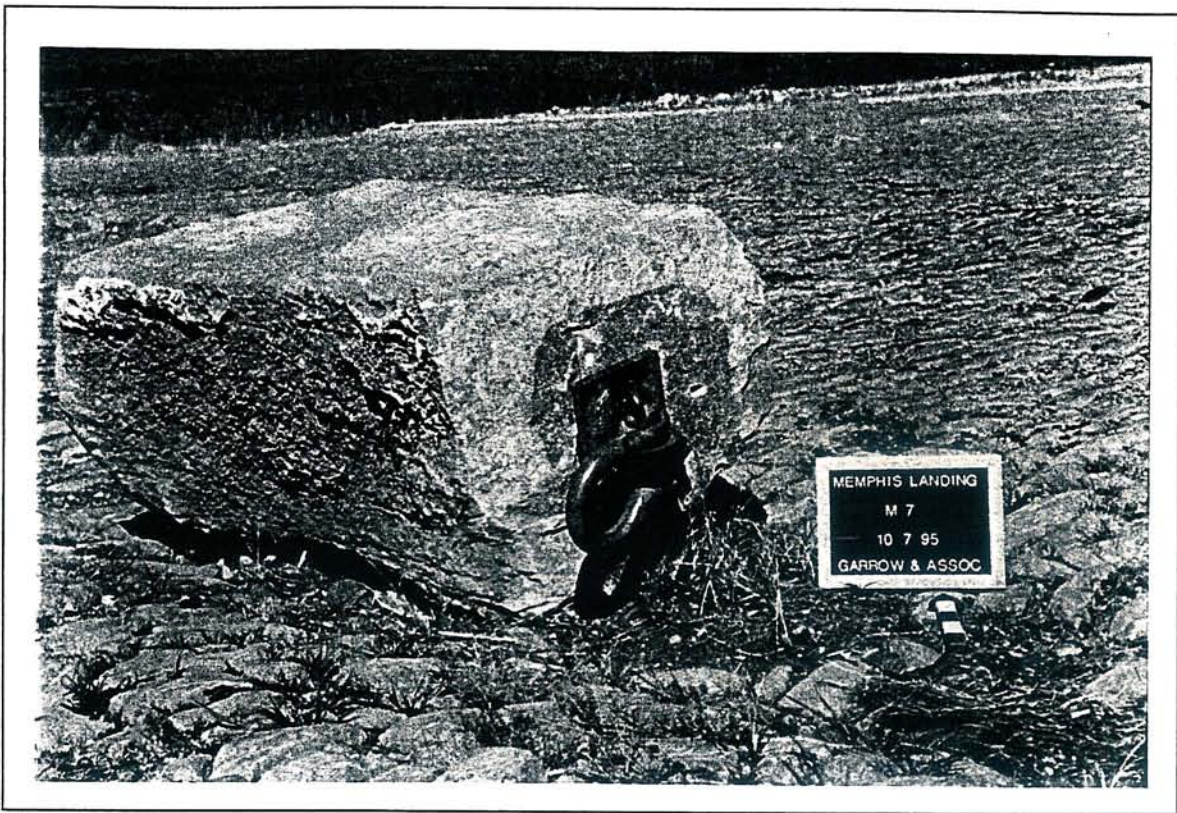
Figure 26. Mooring Type 3.

Type 3. This type includes four examples (3.6 percent) in the northeastern section of the Landing at North 1600. One of these, M-7, is pulled completely from the ground, exposing the entire mooring. It consists of a rectangular iron plate, 12.0 x 8.0 inches, set into a fossiliferous limestone block by three bars. The limestone block is massive, measuring 27.0 x 27.0 x 50.0 inches. The iron plate has a welded ring and is separated from the stone by a thin layer of cement. The mooring was dislodged when high winds blew a moored vessel several feet to the north.

The location and overall condition of the other mooring types suggest they are later additions. The four Type 3 moorings appear almost new and are probably the most recent. The pan-shaped Type 4 moorings may date from the 1870s or 1880s, but they often appear to be intrusive into the surrounding cobblestone matrix, suggesting they were placed after the major building episodes. The “handmade” moorings classified as Type 5 are also quite recent. The concentration of Type 5 moorings between North 400 and North 600 suggests they were constructed and used by the Waterways Marine wharfboats.

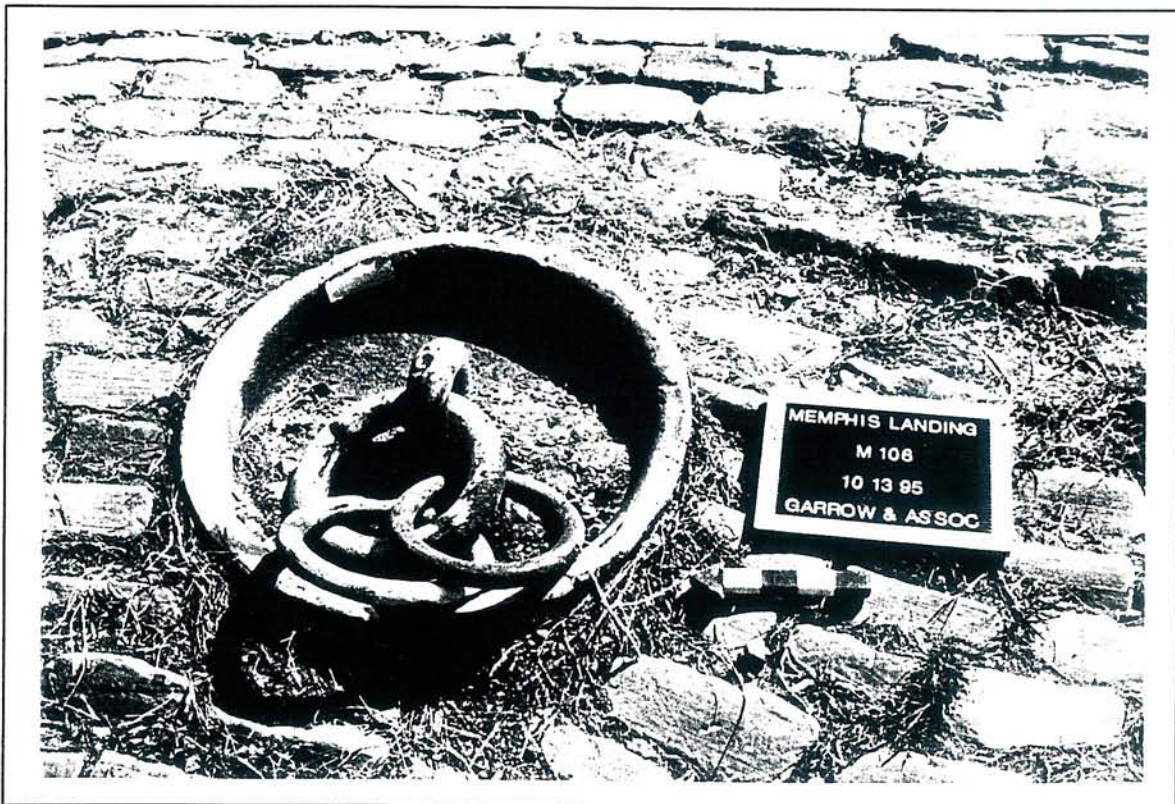
Figure 27. Mooring Type 4.

Type 4. Type 4 moorings (n=12, or 10.7 percent) are distinct in form, consisting of a pan-shaped basin 29.0 inches in diameter. The ringbolt is 7.0 inches in diameter and 2.5 inches thick. These mooring are restricted to south of North 650 and are arranged in pairs perpendicular to the river.

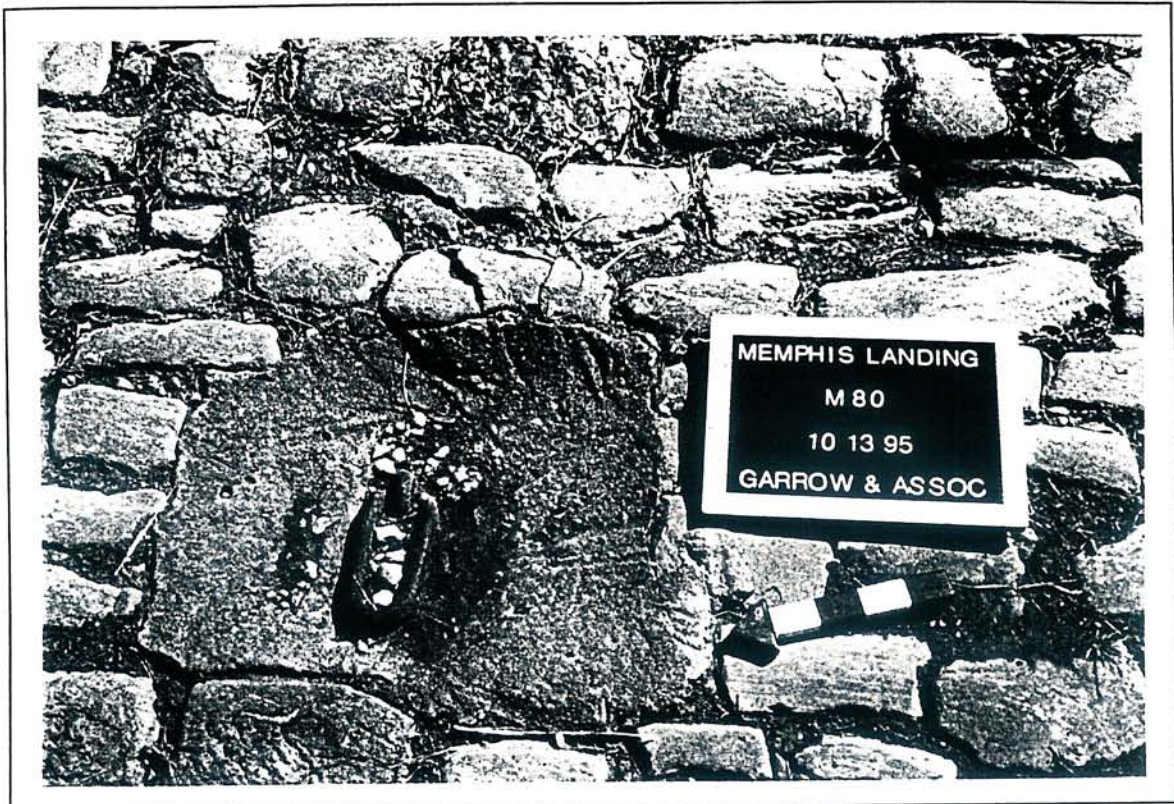
Figure 28. Mooring Type 5.

Type 5. This category (n=10, or 8.9 percent) includes a variety of different forms, all apparently noncommercial in manufacture. Many consist of a simple bent iron bar set in concrete. Type 5 moorings are found south of Monroe Avenue (North 1300), with seven examples concentrated between North 600 and North 400.

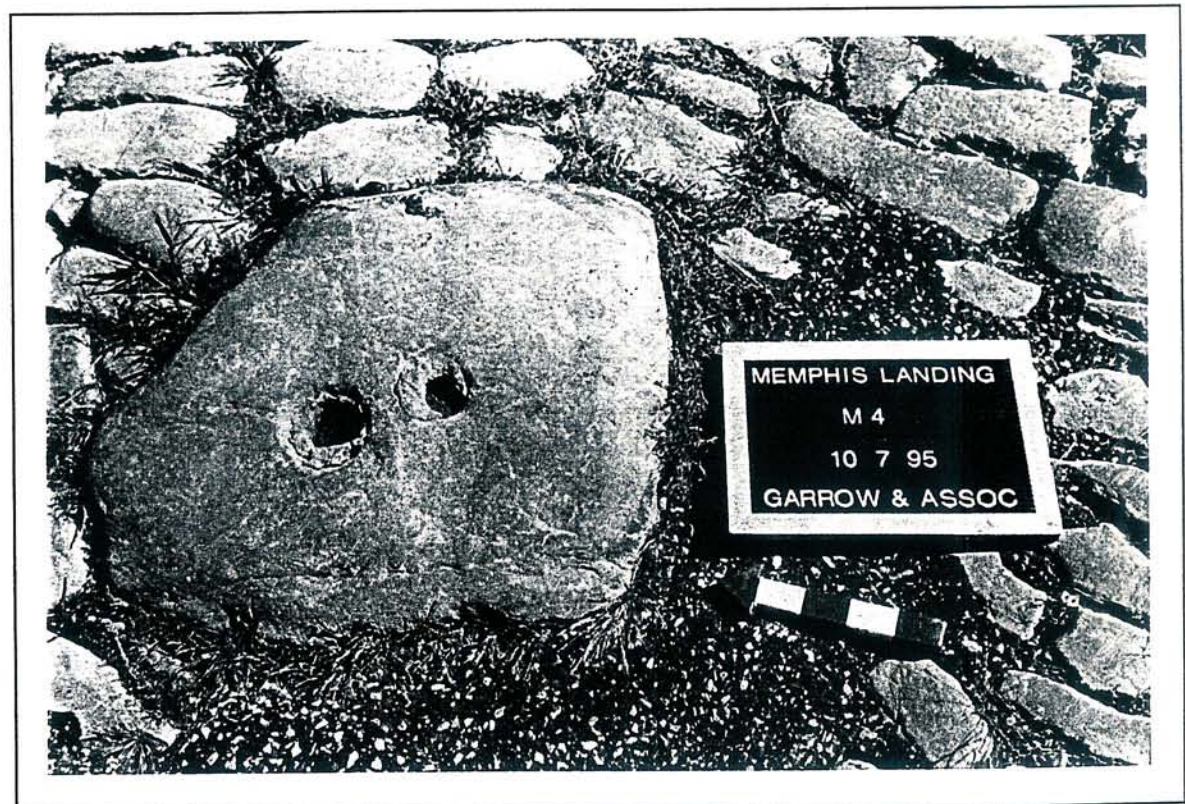
Figure 29. Mooring Type 6.

Type 6. This is the most unusual category of mooring at the Landing, consisting of five (4.5 percent) large fossiliferous blocks exhibiting one or two drilled holes partially filled with lead. It is assumed some sort of iron ring was attached, although their function as moorings cannot be confirmed at this time. These features are exclusive to the northern half of the Landing between North 1900 and North 950. No examples are found south of Union Avenue.

The first example, M-4, is at North 1830/West 30. The limestone block is roughly pentagonal (approximately 27.0 x 21.0 inches). Two holes, 3.5–4.0 inches in diameter, are spaced 5.5 inches apart. Both holes are partially filled with lead. M-27 (North 1305/West 0) has a square exposure measuring 22.0 x 24.0 inches with a single drilled hole 3.25–3.75 inches in diameter. M-36 (North 1220/West 10) measures approximately 28.0 x 23.0 inches, with two drilled holes 3.5–4.0 inches in diameter. The stem of an iron link is attached to one of the holes with lead. The fourth example, M-46 (North 1130/East 25), measures approximately 29.0 x 27.0 inches and has a single lead-filled hole about 2.5 inches in diameter. The southernmost example, M-59 (North 970/East 40), is a square block of limestone measuring approximately 27.0 x 28.0 inches. A single irregular hole about 2.5 inches across was drilled. A twisted iron bar fragment is in the hole, but no lead remains.

Type 6 moorings are also restricted to the northern part of the Landing. These limestone blocks with lead-filled holes seem to fit with the surrounding stone matrix and are also probably associated with the 1860s construction stages. The five examples tend to be located along the eastern side of the Landing. Whether they represent an original form predating the Type 1 moorings is unknown.

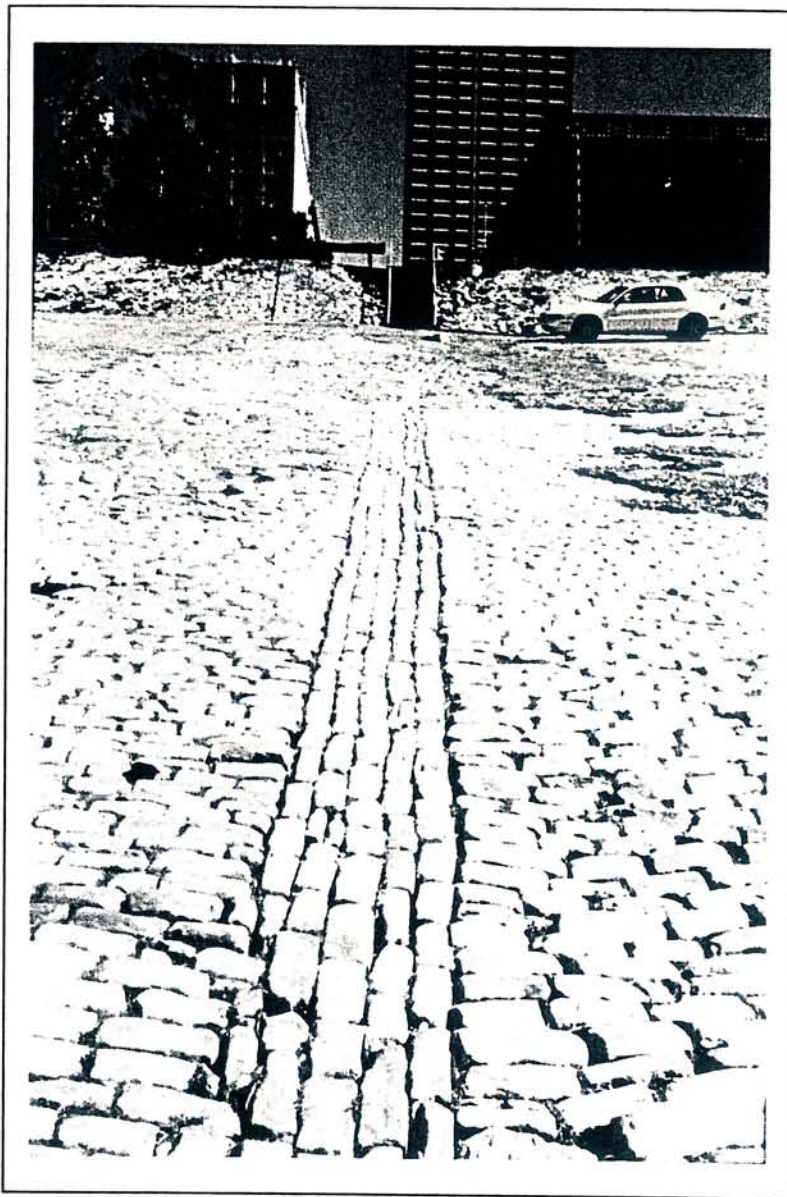
Figure 30. Drainage 3 (View to the East).

Drainage 3 crosses the baseline at about North 1250 (Figure 30). West of the baseline, the drainage consists of six courses of perpendicular Type 2 stones. The use of oolitic limestone in this section of the Landing suggests that the drainage is younger than the surrounding Type 1 matrix. East of the baseline, the drainage pattern branches into two diagonal drainage patterns (at about 30 degrees to the main stem) composed of Type 1 stones. The two diagonal patterns are totally obscured by small, discontinuous repair patterns at their eastern ends. The drainage is obliterated at North 1250/West 65 by recent repairs near the 10 foot watermark.

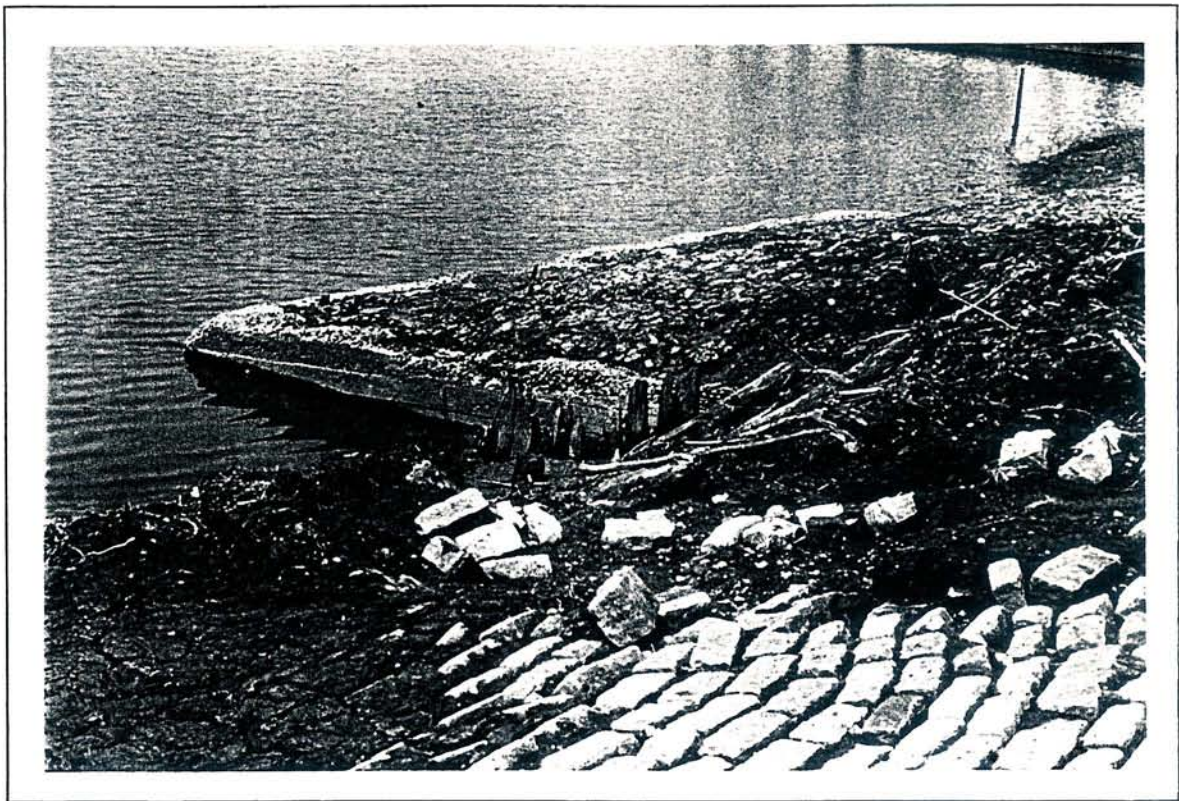
Figure 32. Gayoso Street Sewer (View to the North).

The Gayoso Street sewer drains into the harbor at North 400 (Figure 32). The sewer was constructed after the original stone fabric, as evident in Pattern 10a (Appendix 1). A manhole cover is about midway between the water's edge and the service road. This feature may represent the massive Memphis Siphon storm water sewer constructed ca. 1915-1920.

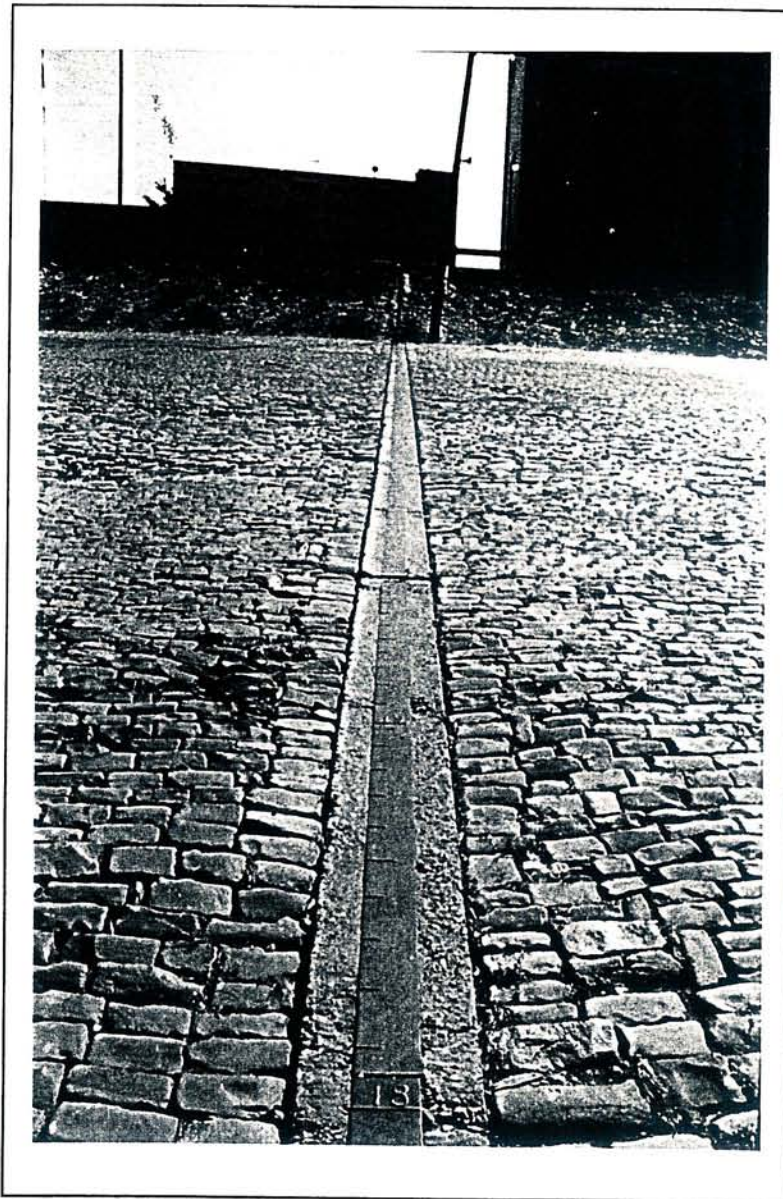
Figure 34. Beale Street Gauge (View to the East).

The Beale Street River Gauge, at about North 150, is an iron ribbon 6.0 inches wide set in a concrete foundation 16.0 inches wide (Figure 34). The gauge is in two sections and is marked in tenths of feet. On the Landing proper, the distance between one-foot marks is 80.0 inches (1:6.66 slope). At the western edge, the gauge is covered by sediments below the 9.2 foot mark; the stone paving begins at about 10.0 feet. On the east, the gauge becomes part of the Riverside Drive berm at the 35 foot mark. The gauge top at the roadway level is 48 feet. On the berm, the one-foot marks are 22 inches apart (1:1.83 slope). Given that the gauge does not appear to run under the berm, the gauge probably was constructed sometime after Riverside Drive (ca. 1935).
